RE: Results of a directed RPO Wetland Survey for the Sundale Subdivision Project, TM 5466

This report presents the results of a directed Resource Protection Ordinance (RPO) wetland survey of the Sundale Subdivision project site (TM 5466). The project site is located at 1612 Hillsdale Road in the Valle de Oro area of unincorporated San Diego County (Figure 1).

Attachments: Figure 1. Site Location
Figure 2. RPO Wetland Exhibit
Attachment A. Site Photos showing RPO Wetlands and associated SWS

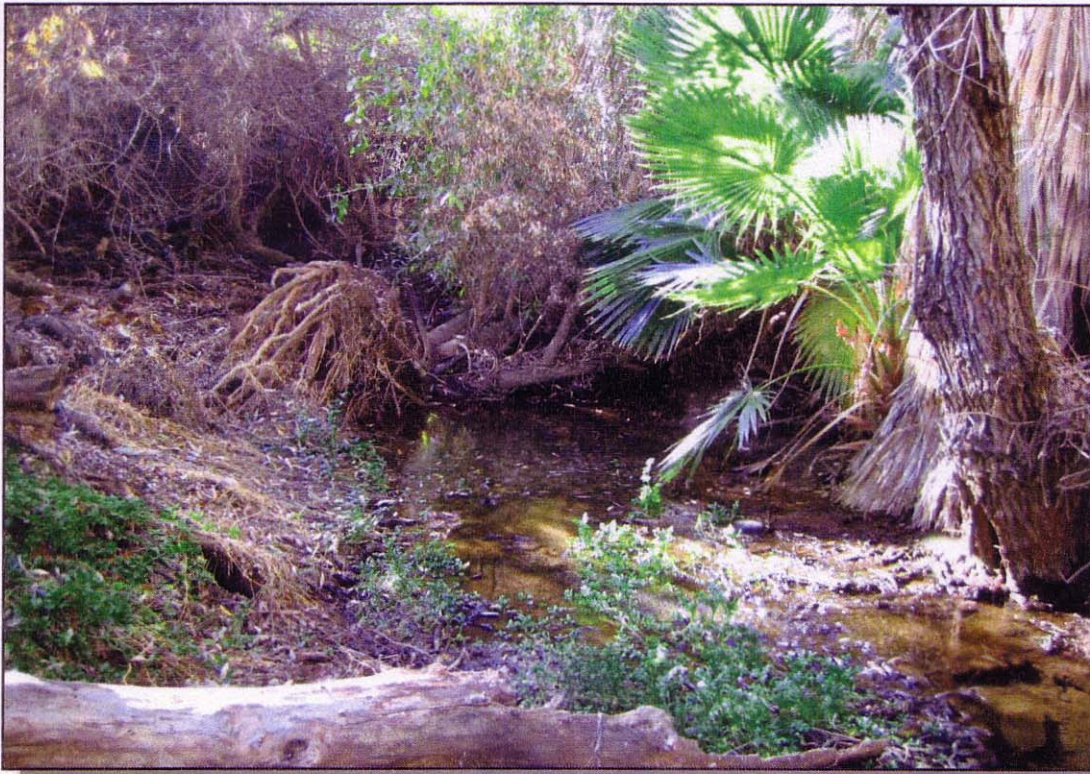
Photo 1. Photo of Jamacha Creek, looking south, where it runs just offsite near the middle of the western property boundary. Plants growing in the floodway at this point include White Watercress, Common Celery, Mule Fat, and Mexican Fan Palm. Note that the drainage consists of a shallowly-incised channel that is approximately 10 feet wide in this location.

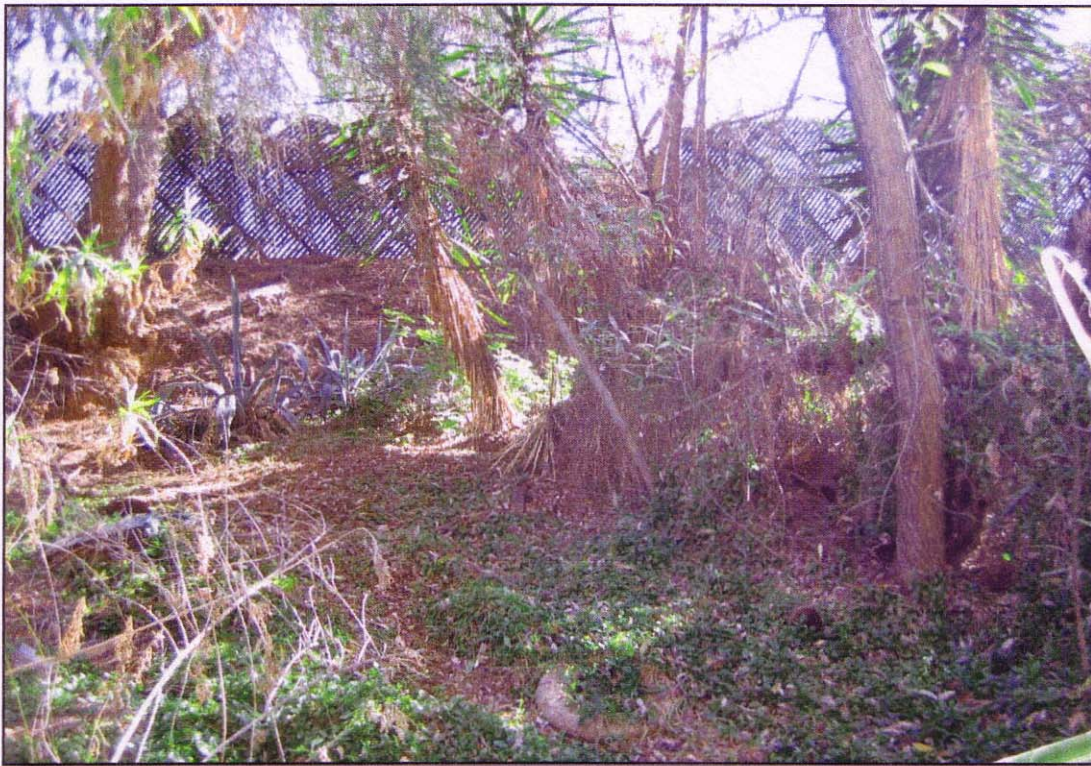
Photo 2. Photo taken from the same location as above, looking east (away from the drainage) and towards the chain-link fence that runs inside the western property boundary. In this location, the slope above the drainage supports Red Apple Iceplant, Peruvian Pepper, Bastard Sandlewood, Ornamental Yucca, and American Agave, all of which are upland species. Straggly seedling willows are present in this location, although the predominance of the vegetation is clearly non-wetland. This area does not qualify as RPO wetlands.

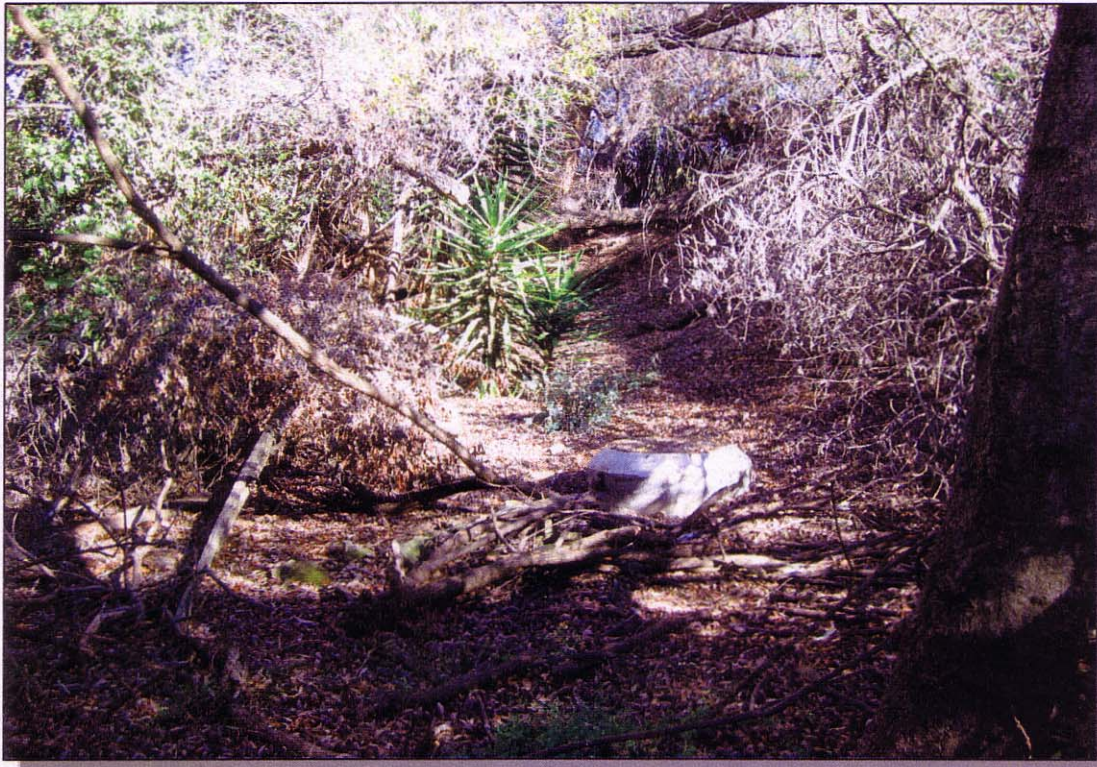
Photo 3. Photo looking north along benched area. Note man-hole above sewer line and ornamental vegetation. The canopy in this location consists primarily of Bastard.Sandlewood. The RPO wetland is located to approximately 20 feet to the left of this picture at this location.

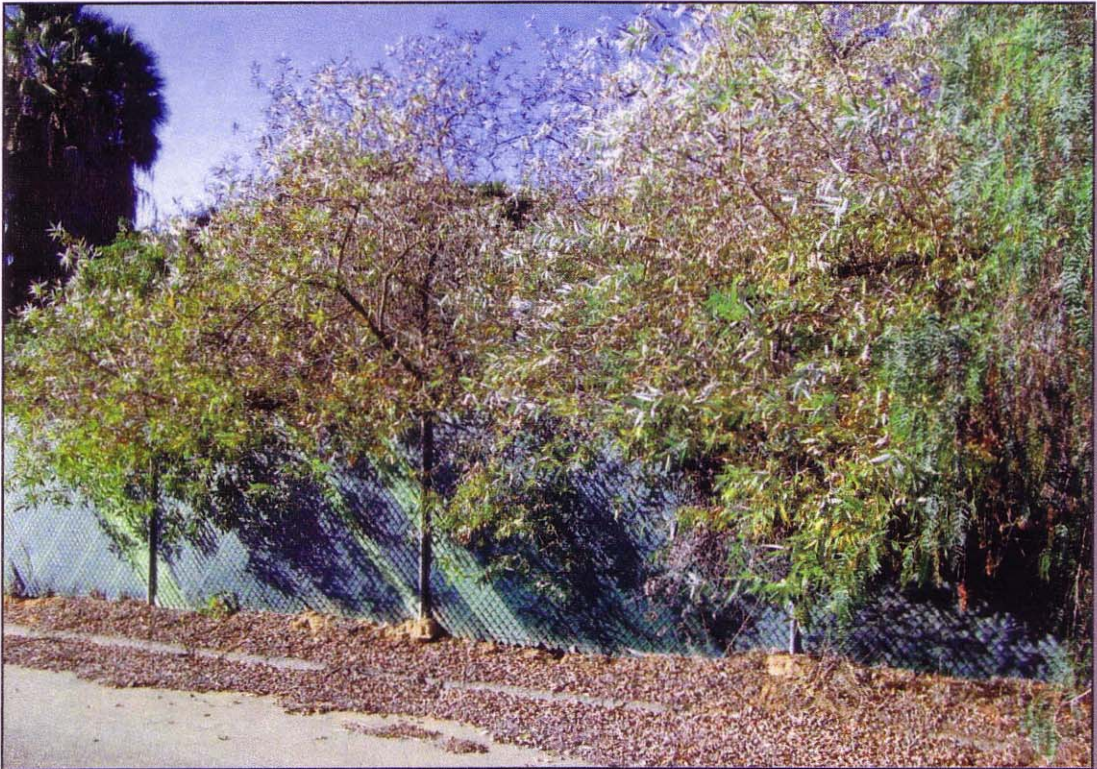
Photo 4. Photo taken from the central part of the property looking west, showing willow canopy of the SWS as it runs up the slope above the sewer line and over the fence. No willows are growing in close proximity to this fence – the vegetation above consists entirely of canopy overhang. The trunks of the willows shown in this photo are actually growing within 10 feet of the drainage.
